A full Corrosion Control™ System installed  
at a Wawa site in Manassas, Virginia USA.

# SOLVING CORROSION WITH WAWA

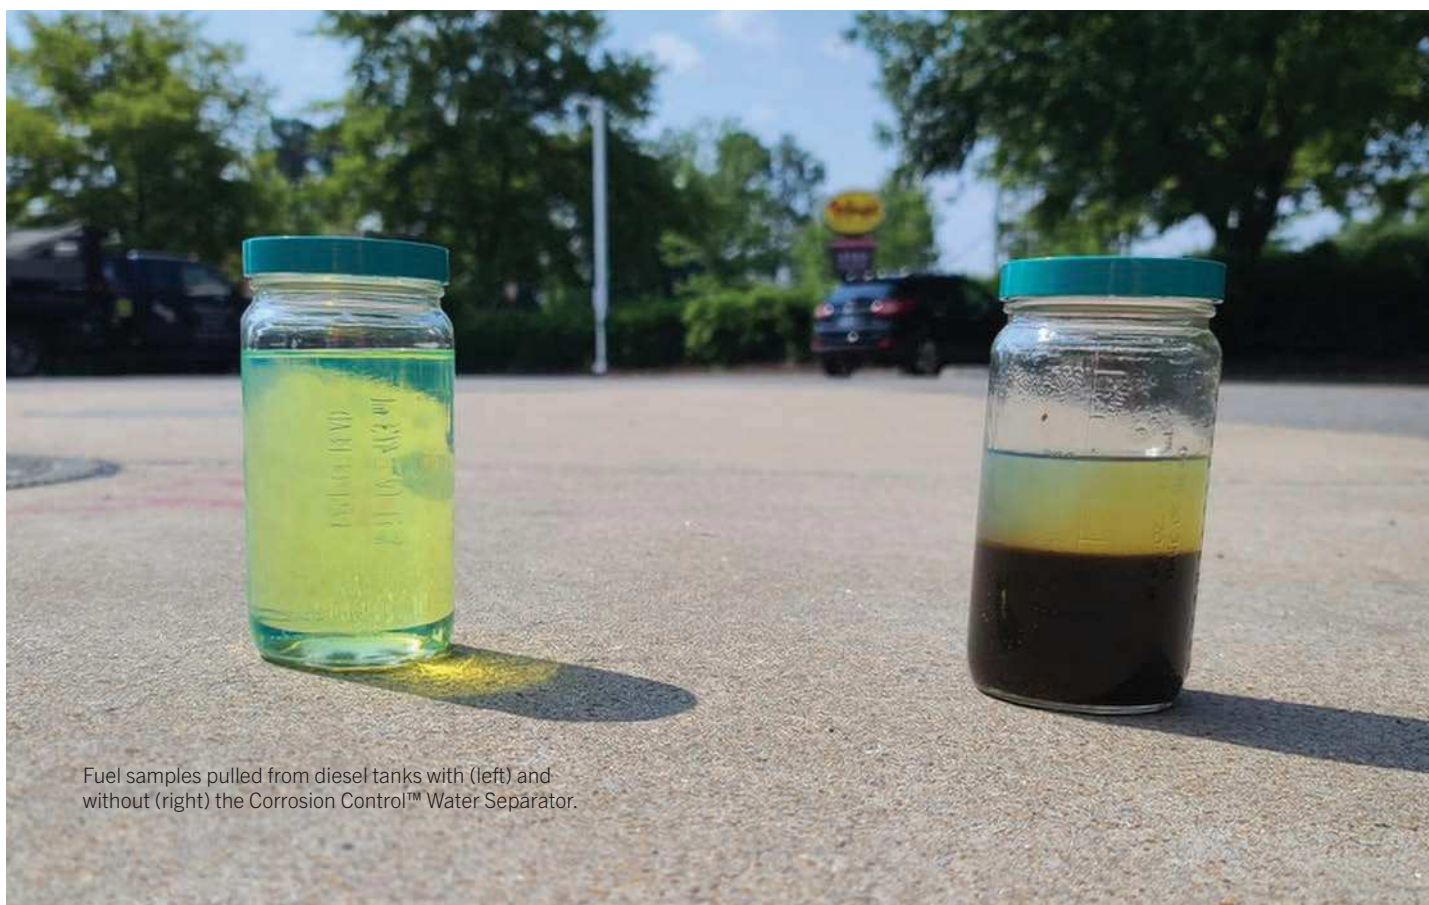
Fuel samples pulled from diesel tanks with (left) and without (right) the Corrosion Control™ Water Separator.

Franklin Fueling Systems installed the first Corrosion Control™ Water Separator System at one of the worst corrosion-affected Wawa sites. After just 90 days of proactively removing the water from the bottom of the tank, the new system was yielding clean, clear diesel fuel and the submersible pump components were free of corrosion and easy to inspect and test. Because water is heavier than diesel fuel, it will fall to the bottom of the tank. Using this same principle, Franklin separates the water from the fuel inside the Water Separator’s collection vessel to trap the water and return clean fuel to the tank.

“This picture tells the story better than anything written – these bottom samples come from a store that has two diesel tanks, one with, and one without a water separator,” said Beu.
